Manhole Inspection Summary

Manhole # S45M__019MH

Insp Date: **6/6/08 9:16 AM**

Location Address: **1716 thames st**

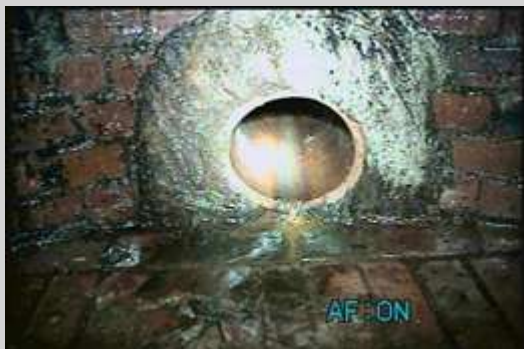
3 O'Clock Inflow

8 in. Circular Gravity Sewer
Pipe In @ 3 OClock

Pipe Height: **0** (in.) Direct
Pipe Material: **Clay** ☐ Pipe Lined
Invert Depth: **10.66** (ft.) Flow Characteristics: **Fast**
Deposits: ☒ None ☐ Mud ☐ Sludge ☐ Debris ☐ Grease
Silt Depth: **0** (in.) Deposits Extent:
Infiltration: **None** Pipe Seal Cond: **Unknown**

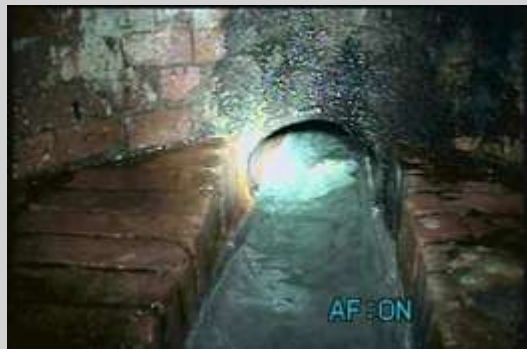
6 O'Clock Inflow

8 in. Circular Gravity Sewer
Pipe In @ 6 O'Clock
